Manhole Inspection Summary

Manhole # S37EE1014MH

Insp Date: **4/18/07 11:15 AM**

Location Address: **3722 OLD YORK RD** Cross Street: **CHESTNUT HILL**

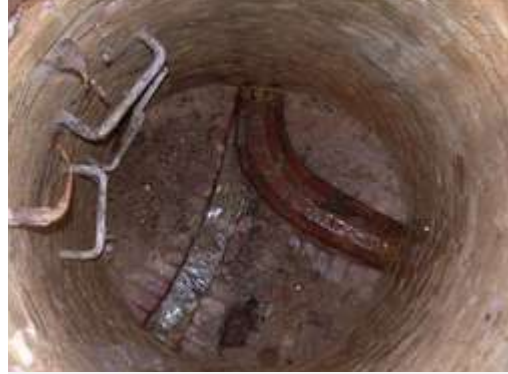
Top View

Corroded and missing steps. Evidence of surcharge - Bench debris. Channel debris.

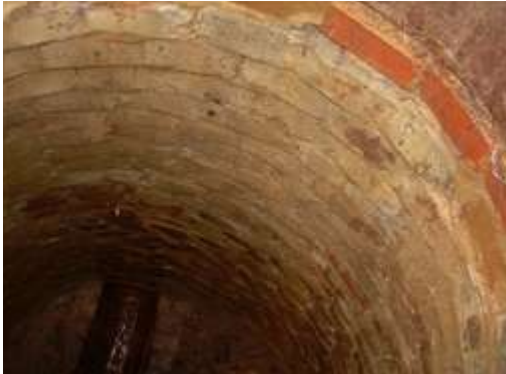
Defect

Frame leaks. Adjustment deterioration and infiltration. Barrel infiltration.

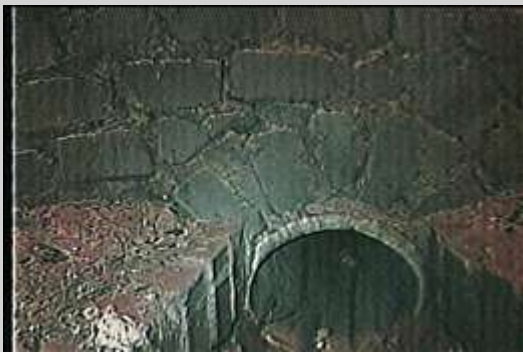
8 in. Circular Gravity Sewer Pipe Out @ 12 O'Clock

Barrel deterioration and infiltration.

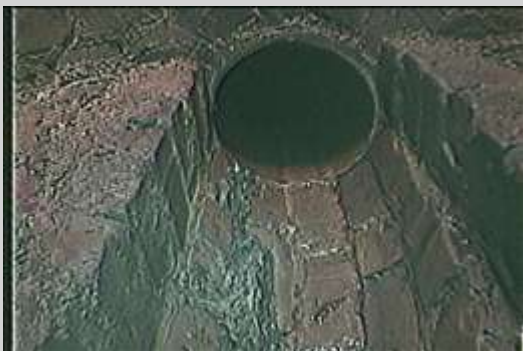
8 in. Circular Gravity Sewer Pipe In @ 4 O'Clock

Channel deterioration.

Infiltration: **Evidence** Pipe Seal Cond: **Unknown**

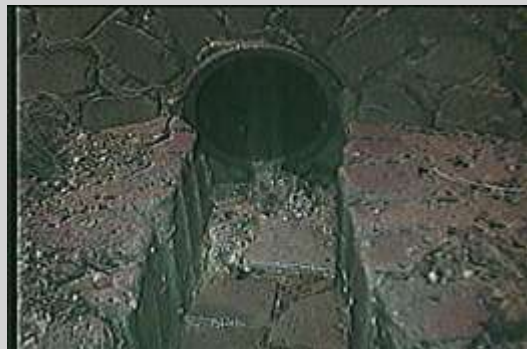
Pipe In @ 6 O'Clock

Barrel deterioration and infiltration. Bench and Channel deterioration.

Infiltration: **Evidence** Pipe Seal Cond: **Cracked**
